ANNUAL REPORT FOR 2009

**UT to Irish Buffalo Creek Mitigation Site
Cabarrus County
TIP No. R-2533B (Site 12)**

Prepared By:
Natural Environment Unit & Roadside Environmental Unit
North Carolina Department of Transportation
October 2009

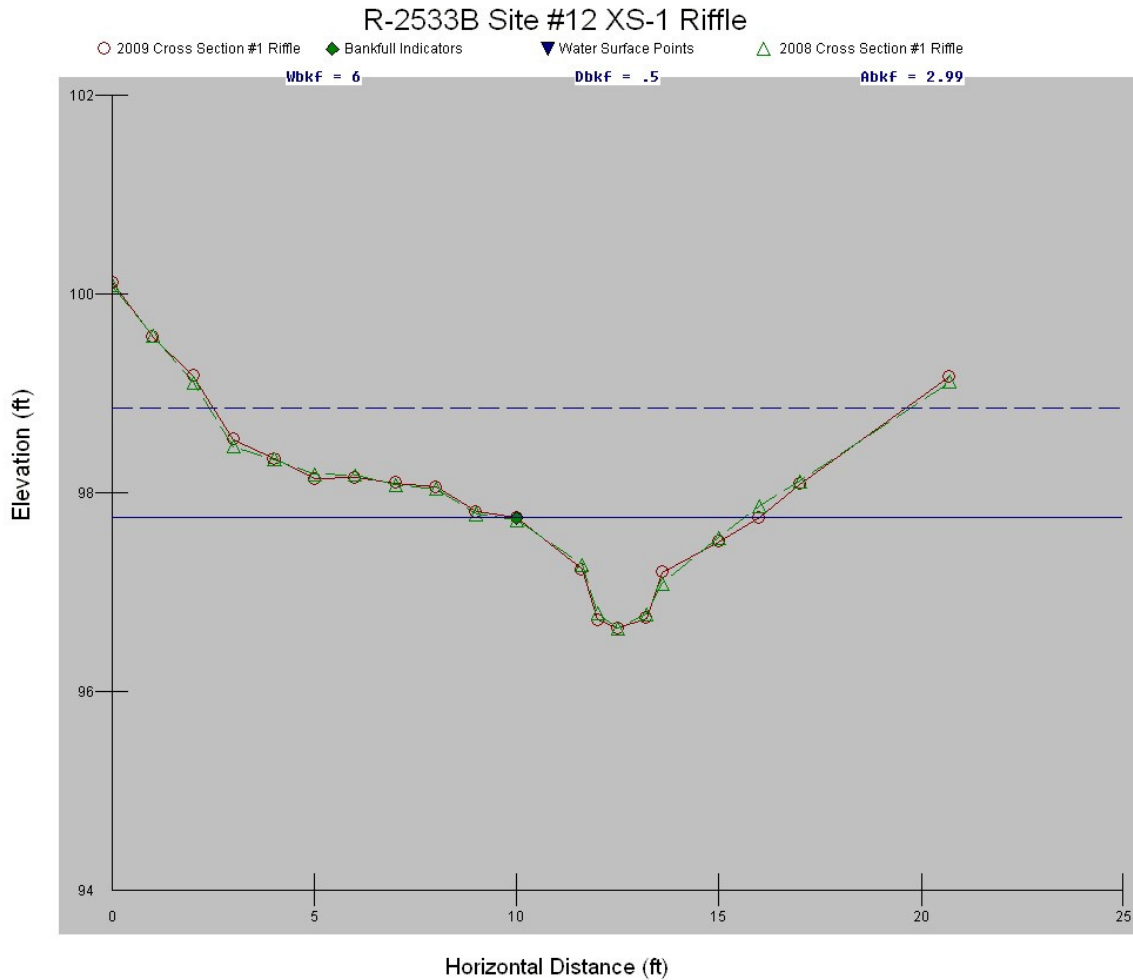
Site #12: Cross-Section #1 (Riffle) Abbreviated Morphological Summary

Based on comparisons of Year 2008 and Year 2009 monitoring data, all of the cross sections appear stable with little or no active bank erosion. Graphs of the cross sections are presented in Appendix A. Future survey data will vary depending on actual location of rod placement and alignment; however, this information should remain similar in appearance. Pebble counts were not required per the permit conditions and therefore were not completed.

2008	2009	2010	2011	2012
Bankfull Cross Sectional Area (ft²)	2.8	3			
Maximum Bankfull Depth (ft)	1.1	1.1			
Width of the Floodprone Area (ft)	17.1	17.1			
Bankfull Mean Depth (ft)	0.5	0.5			
Width/Depth Ratio	11.1	12			
Entrenchment Ratio	3.1	2.9			
Bankfull Width (ft)	5.6	6

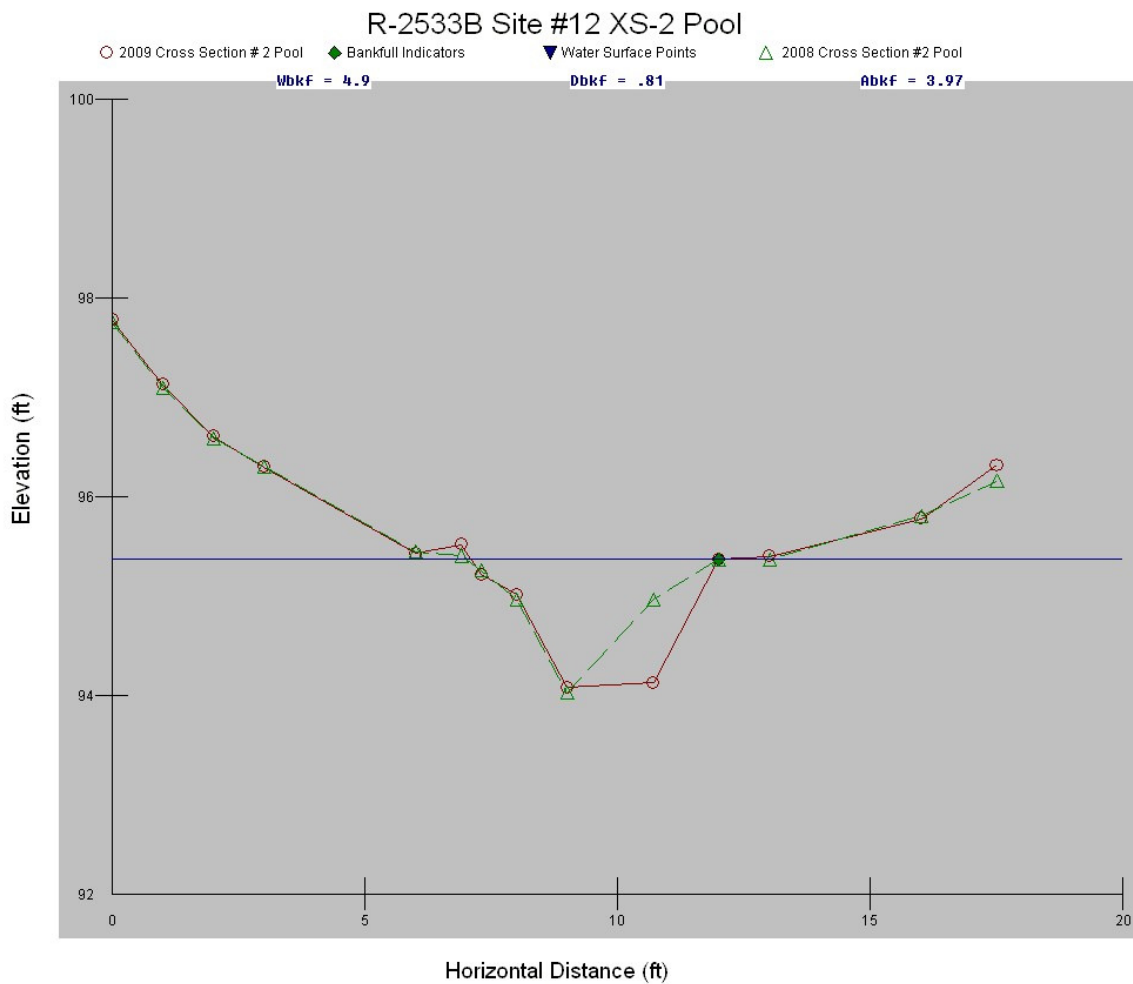
Site #12: Cross-Section #2 (Pool) Abbreviated Morphological Summary*

2008	2009	2010	2011	2012
Bankfull Cross Sectional Area (ft²)	2.8	3.9			
Maximum Bankfull Depth (ft)	1.3	1.3			
Bankfull Mean Depth (ft)	0.7	0.8			
Bankfull Width (ft)	4.9	4.9
